## Natural Resources Assessment I-25 Erie Gateway – South PD District Erie, Weld County, Colorado

ERO Resources Corporation  
1626 Cole Boulevard, Suite 100  
Lakewood, Colorado 80401  
(303) 830-1188  
ERO Project #22-216

May 24, 2023

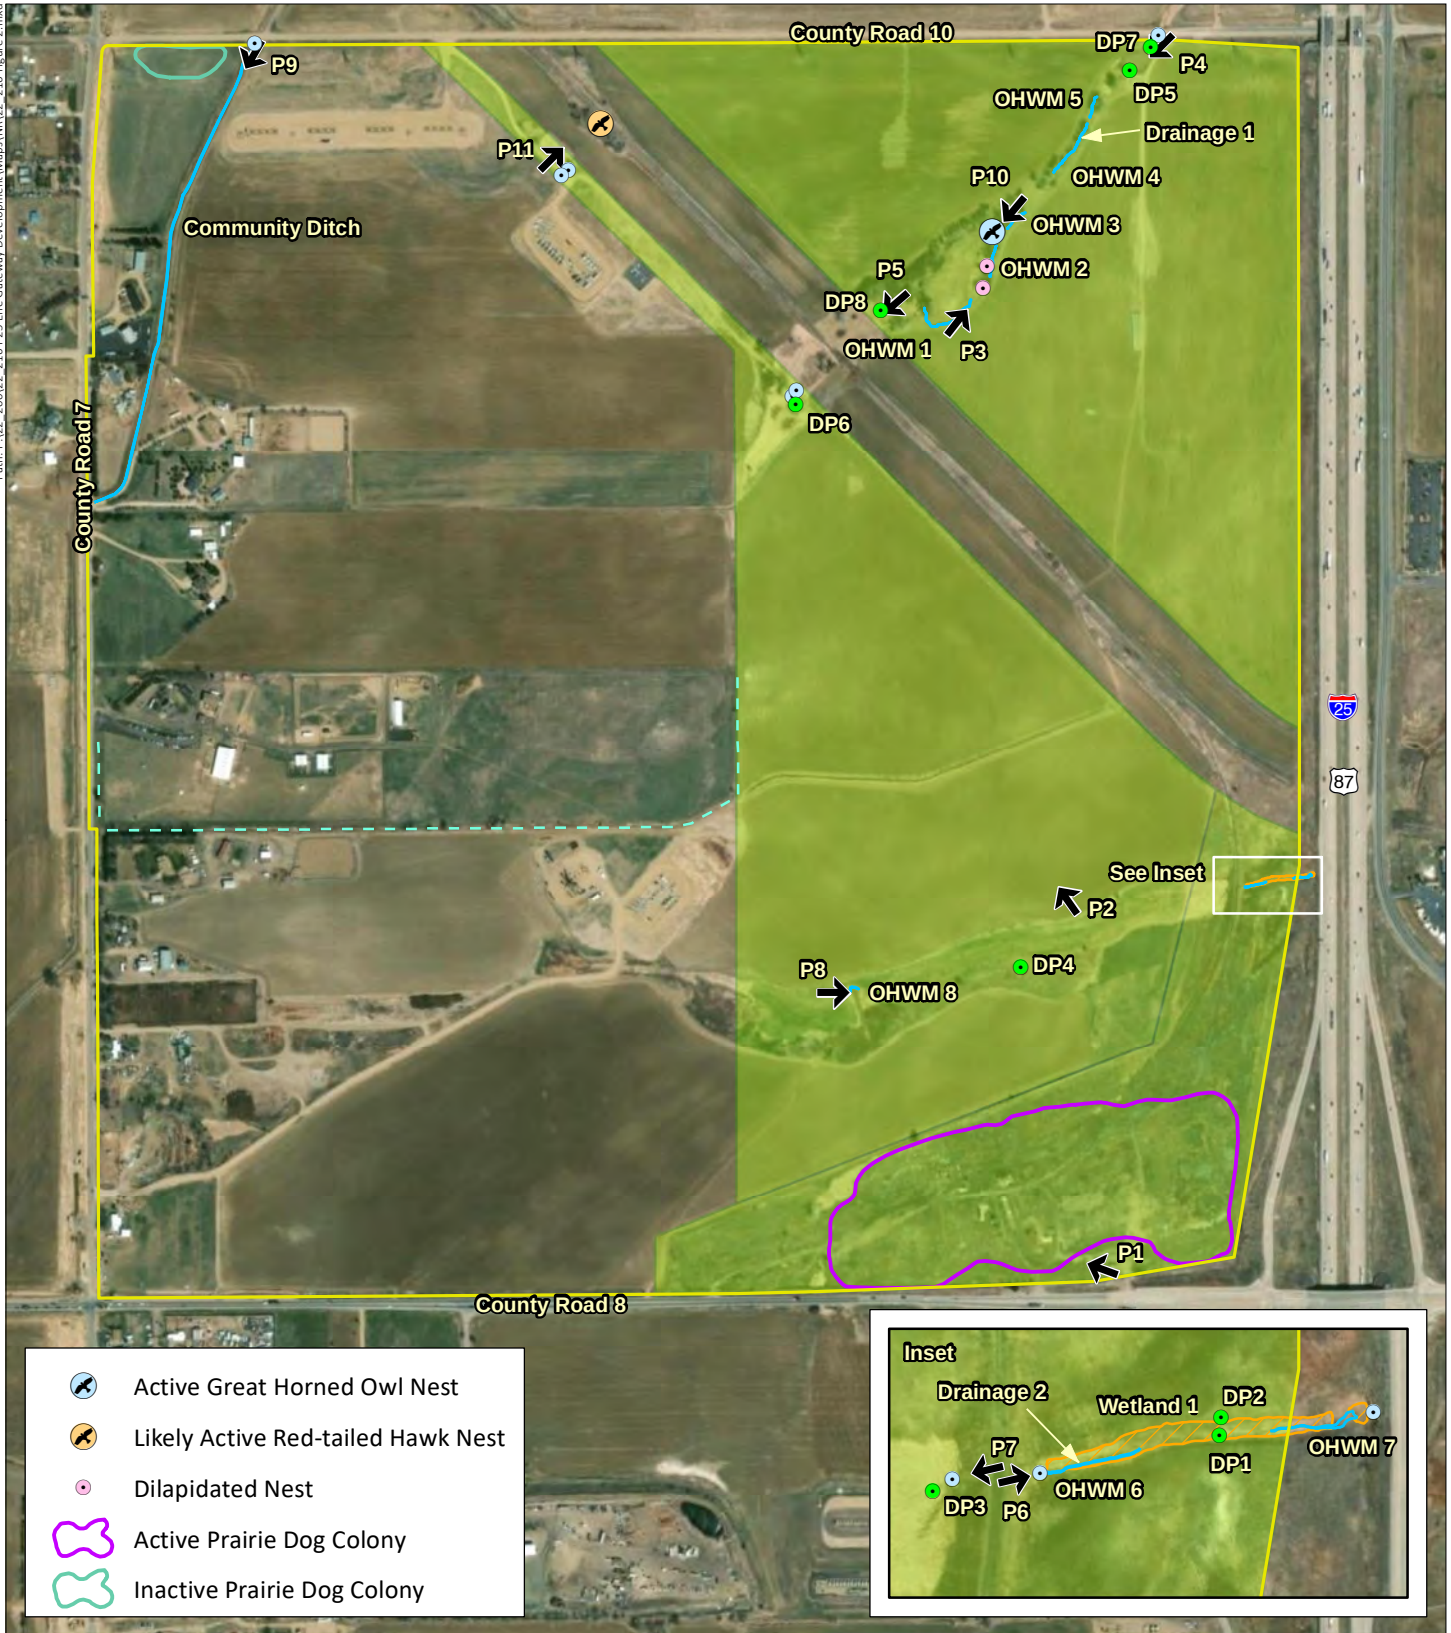
Figure 2  
Existing Conditions

- Data Point
- Culvert
- ➔ Photo Point
- Wetland (0.092 ac)
- Ordinary High Water Mark (0.129 ac)
- Lateral Ditch
- Town-Owned Parcel
- Project Area Boundary

Active and inactive black-tailed prairie dog (*Cynomys ludovicianus*) burrows occur in the southeastern (Photo 1) and northwestern portions of the project area (Figure 2). Five raptor nests and several dilapidated nests, including one active great-horned owl nest and one possible red-tailed hawk nest, were observed in the project area vicinity during the 2023 site visits (Photos 10 and 11, respectively; Figure 2).

ERO surveyed the project area for nests during the 2023 site visits. ERO observed five raptor nests and several dilapidated old magpie nests within ½ mile of the project area (Figure 2 and Figure 3). One nest in the northeastern portion of the project area was occupied by great-horned owlets during the 2023 site visits (Photo 10), one nest in the northern portion of the project area was attended by a pair of red-tailed hawks but was not yet in use (Photo 11), one active red-tailed hawk nest was observed greater than ⅓ mile southeast of the project area, and one nest occupied by great-horned owl was observed greater than ⅓ mile northeast of the project area. Raptors such as red-tailed and Swainson's hawks could potentially use the observed nests in and adjacent to the project area. Depending on the species, CPW recommends a ⅓- or ¼-mile buffer from active raptor nests from February through July for human encroachment activities or installation of a permanent or long-standing physical object or structure (Colorado Parks and Wildlife 2020a). CPW does not have a published recommended buffer for avoiding disturbance to great-horned owl nests, but a 330- to 600-foot buffer is generally acceptable, depending on activity. The breeding season for most birds in Colorado is March through mid-September, with the exception of a few species that begin breeding in February, such as great-horned owls.

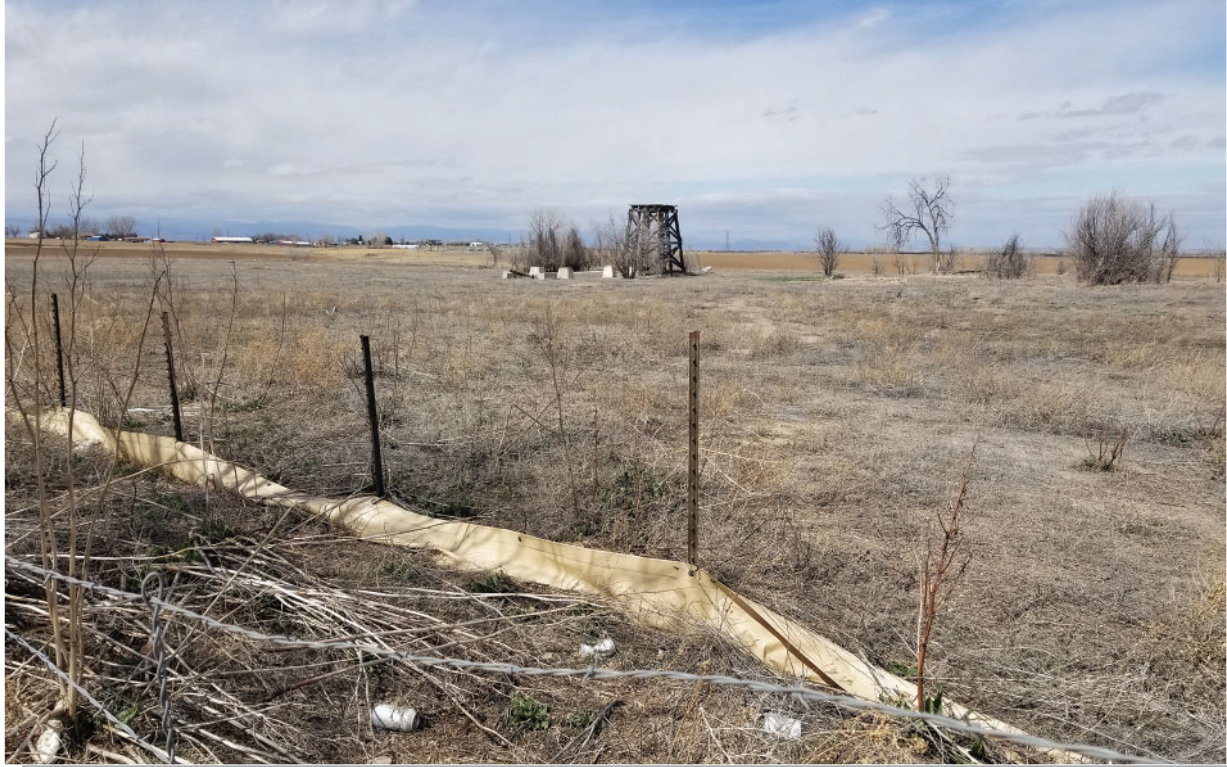
**Photo 1** - Active prairie dog colony, disturbed uplands, and old mine structures in the southeastern portion of the project area. View is to the northwest.

ERO observed active and inactive black-tailed prairie dog burrows along portions of the project area during the 2023 site visits (Figure 2). Although prairie dogs are not protected under the ESA, CPW recommends attempting to remove, translocate, or exterminate prairie dogs prior to bulldozing an active prairie dog town for humane reasons. Currently, the Town and Weld County do not have any regulations or policies pertaining to prairie dogs.

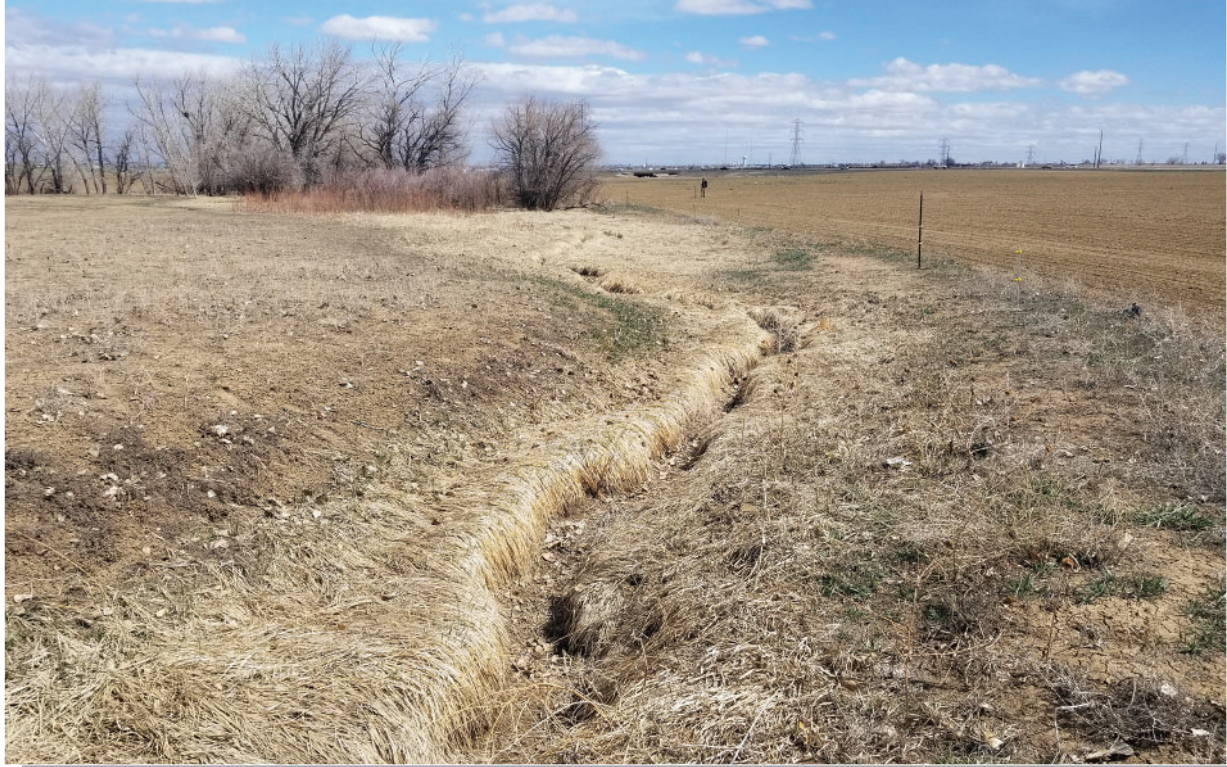
**Photo 3** - OHWM 1 along Drainage 1 and fallow agricultural fields in the northeastern portion of the project area. View is to the northeast.

During the 2023 site visits, Drainage 1 consisted of a mesic riparian corridor with an intermittent OHWM (OHWM 1 through OHWM 5) (Figure 2; Photos 3 through 5). No open water or wetlands were observed in Drainage 1 during the 2023 site visits, as detailed below. Drainage 1 appears to receive water as overland flow runoff from the nearby agricultural fields to the west. Based on the 2023 site visits, Drainage 1 does not maintain a relatively permanent flow and does not appear to have a downstream surface connection to a known WOTUS. ERO believes OHWM 1 through OHWM 5 would be considered nonjurisdictional. Delineation data collected along DPs taken in Drainage 1 (DP5 through DP8) is described in more detail below.

Drainage 1 lacks a relatively permanent flow and does not appear to have a continuous surface connection to downstream water due to dryland breaks. An occasional OHWM (OHWM 1 through OHWM 5) that ranged from 0.5 to 2 feet wide was found along Drainage 1 in the northeast portion of the project area (Figure 2; Photo 3). For these reasons, ERO believes Drainage 1 (OHWM 1 through OHWM 5) would likely be determined nonjurisdictional by the Corps.

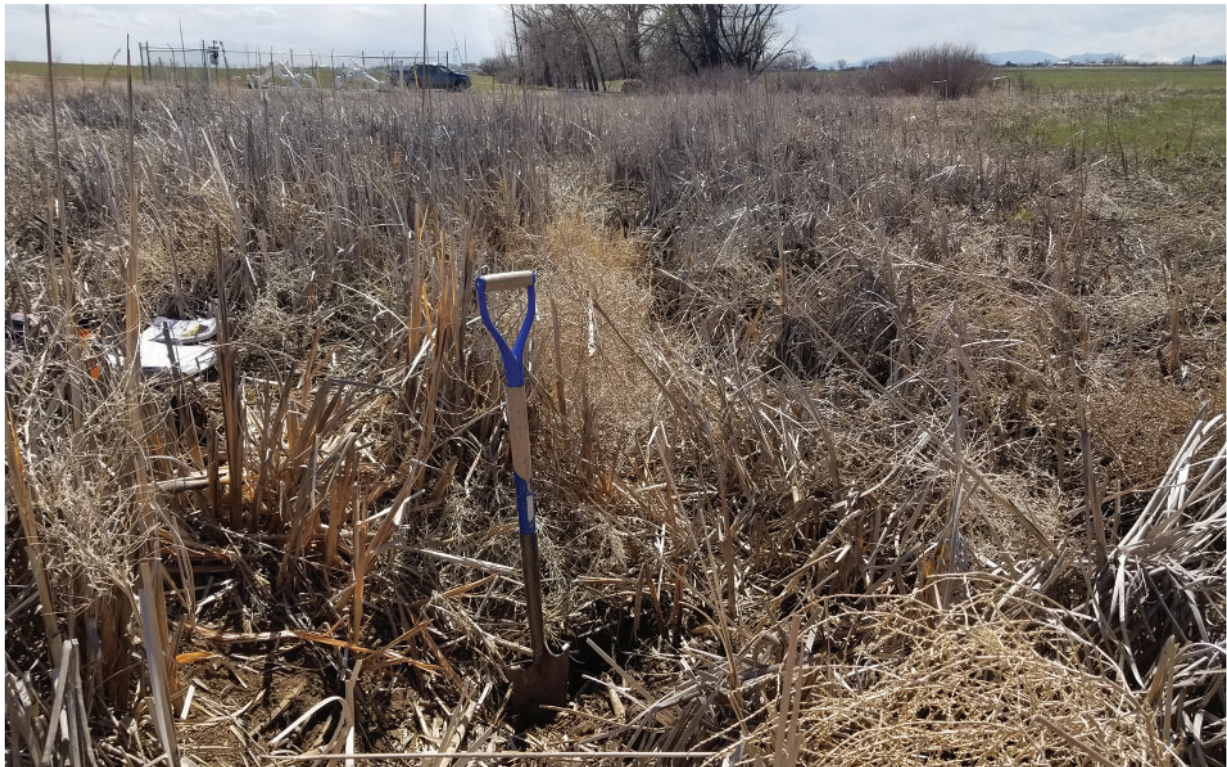
**Photo 4** - DP7 along Drainage 1 in the northeastern portion of the project area. View is to the southwest.

Hydrology indicators were observed at DP5, DP7, and DP8. At DP5 and DP7, no primary hydrology indicators were observed, but secondary indicators of wetland hydrology included geomorphic position and a successful FAC-neutral test. At DP8, no primary hydrology indicators were observed and only one secondary indicator of wetland hydrology (a successful FAC-neutral test) was observed. No primary or secondary hydrology indicators were observed at DP6.

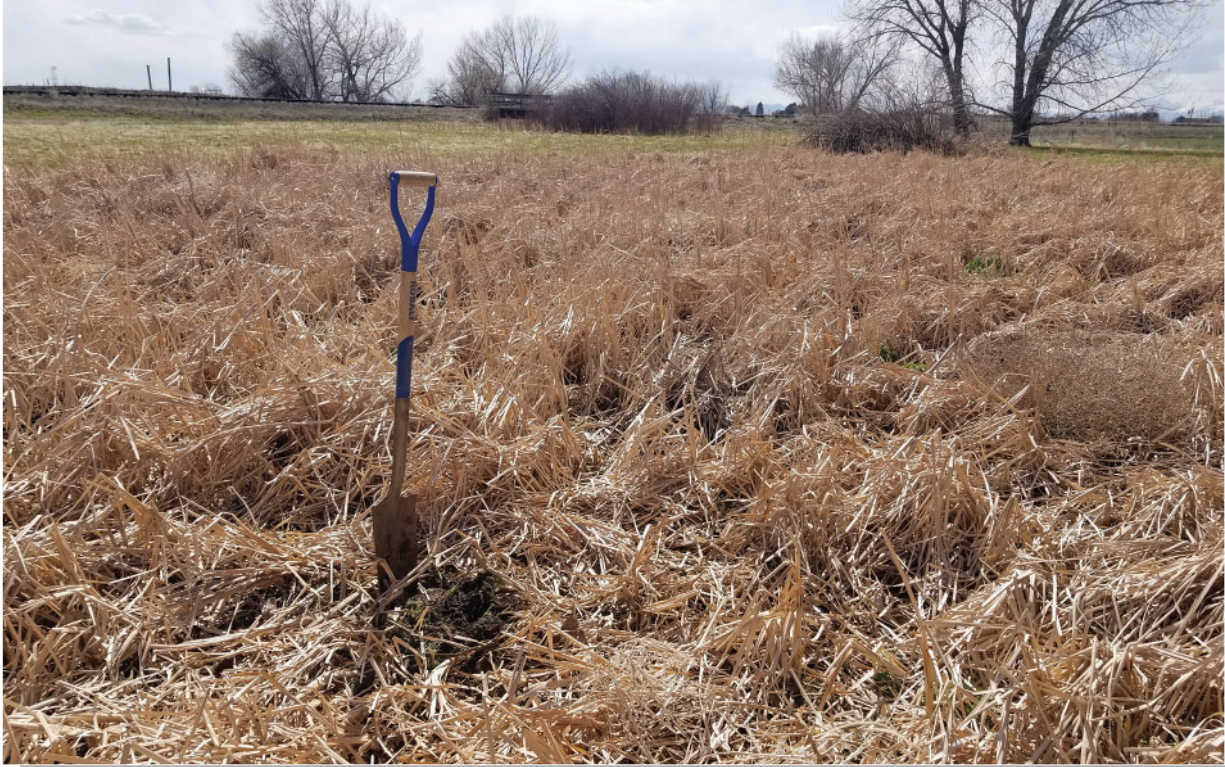
**Photo 5** - DP8 along Drainage 1 in the northeastern portion of the project area. View is to the southwest.

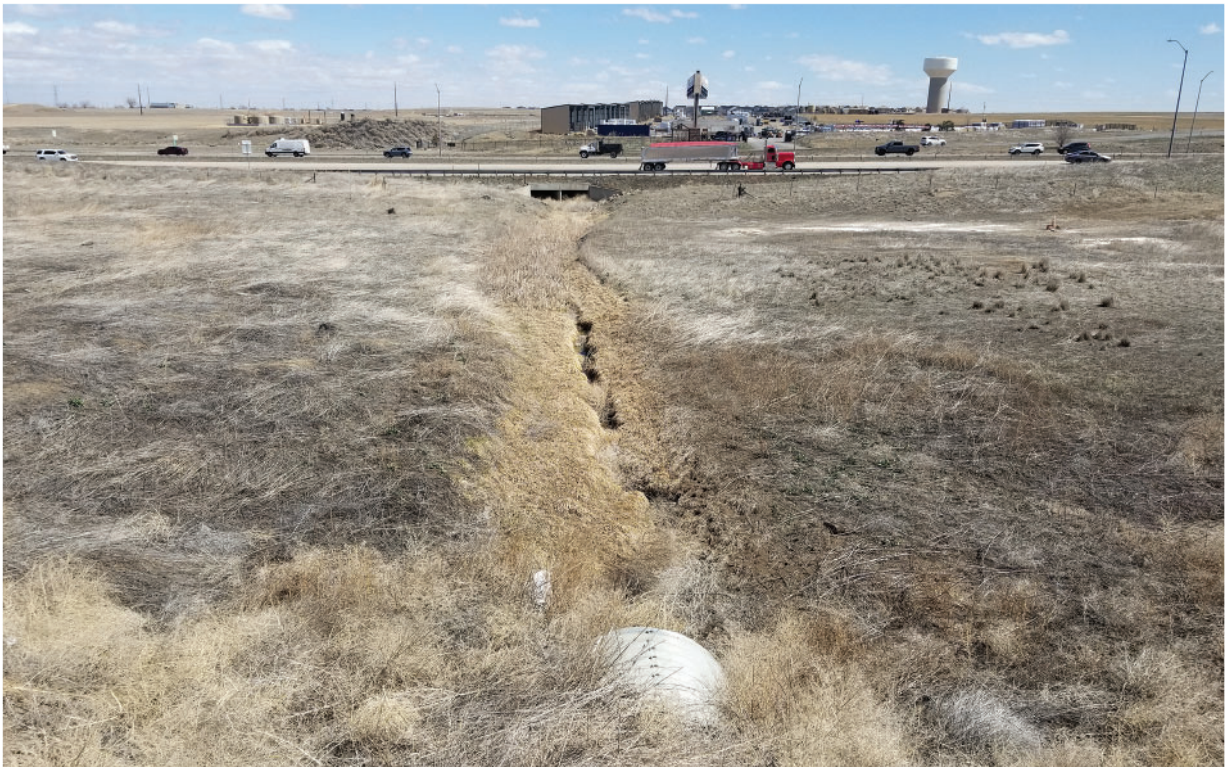
**Photo 6** - Overview of Wetland 1 and OHWM 6 along Drainage 2 in the southeastern portion of the project area. View is to the northeast.

During the 2023 site visits, Drainage 2 consisted primarily of a disturbed upland swale with some areas of wetland (Wetland 1), open water (OHWM 6), and OHWM (OHWM 7) in the eastern portion along a constructed drainageway, and an isolated OHWM (OHWM 8) in the western portion of the drainage swale (Figure 2; Photos 6 through 8). Drainage 2 appears to receive water as overland flow runoff from the nearby agricultural lands to the west and may have additional wetland and other water features located in the project area that occur outside of the Town-Owned Parcels, which could not be observed in the field due to the lack of landowner permission to access. Based on the 2023 site visits, portions of Drainage 2 (OHWM 6 and OHWM 7) may maintain a relatively permanent flow; however, based on review of aerial imagery, it is unclear if these features have downstream surface connections to known WOTUS. ERO believes some features of Drainage 2 may be considered nonjurisdictional, including OHWM 8. Delineation data collected along DPs taken along Drainage 2 (DP1 through DP4) is described in more detail below.

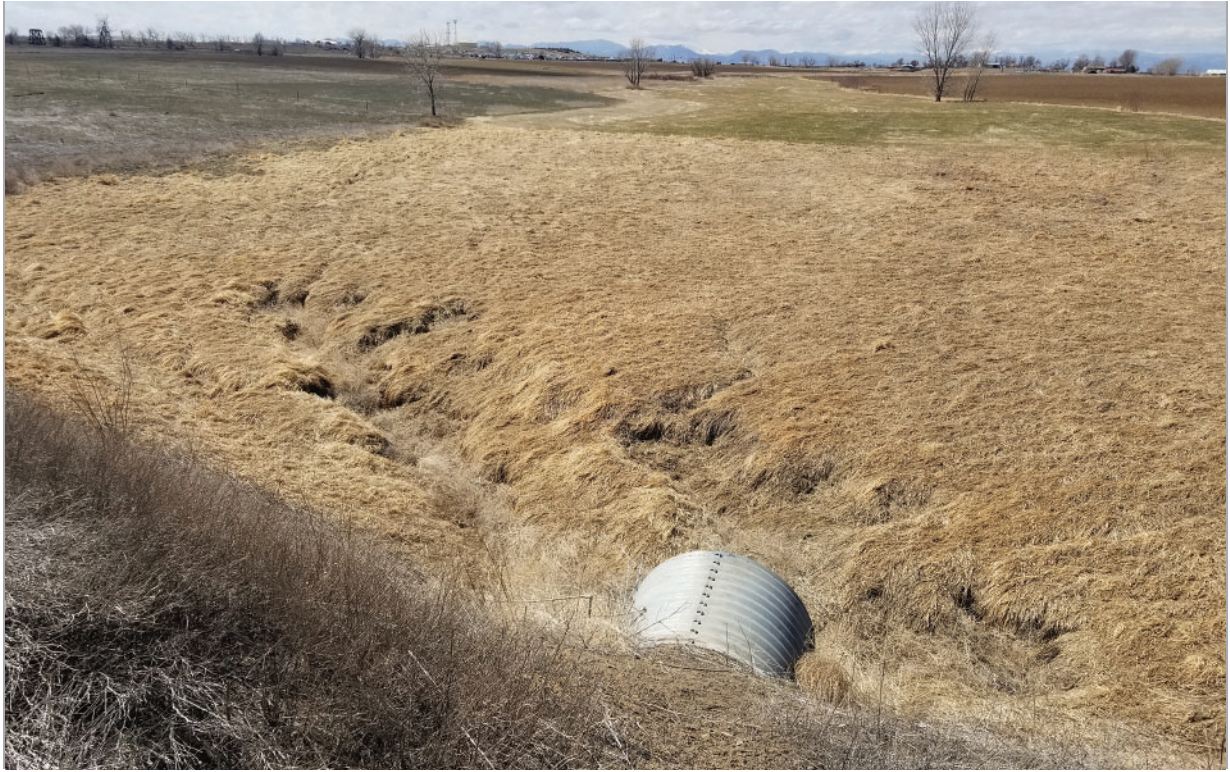
**Photo 7** - Overview of DP3 and Drainage 2 upstream of culvert in the southeastern portion of the project area. View is to the southwest.

Hydrology indicators were observed at DP1, DP3, and DP4. At DP1, primary hydrology indicators observed were saturation and salt crust, and the secondary indicators of wetland hydrology observed included geomorphic position and a successful FAC-neutral test. At DP3, a primary hydrology indicator observed was saturation, and secondary indicators of wetland hydrology observed included geomorphic position and a successful FAC-neutral test. No primary or secondary hydrology indicators were observed at DP2 or DP4.

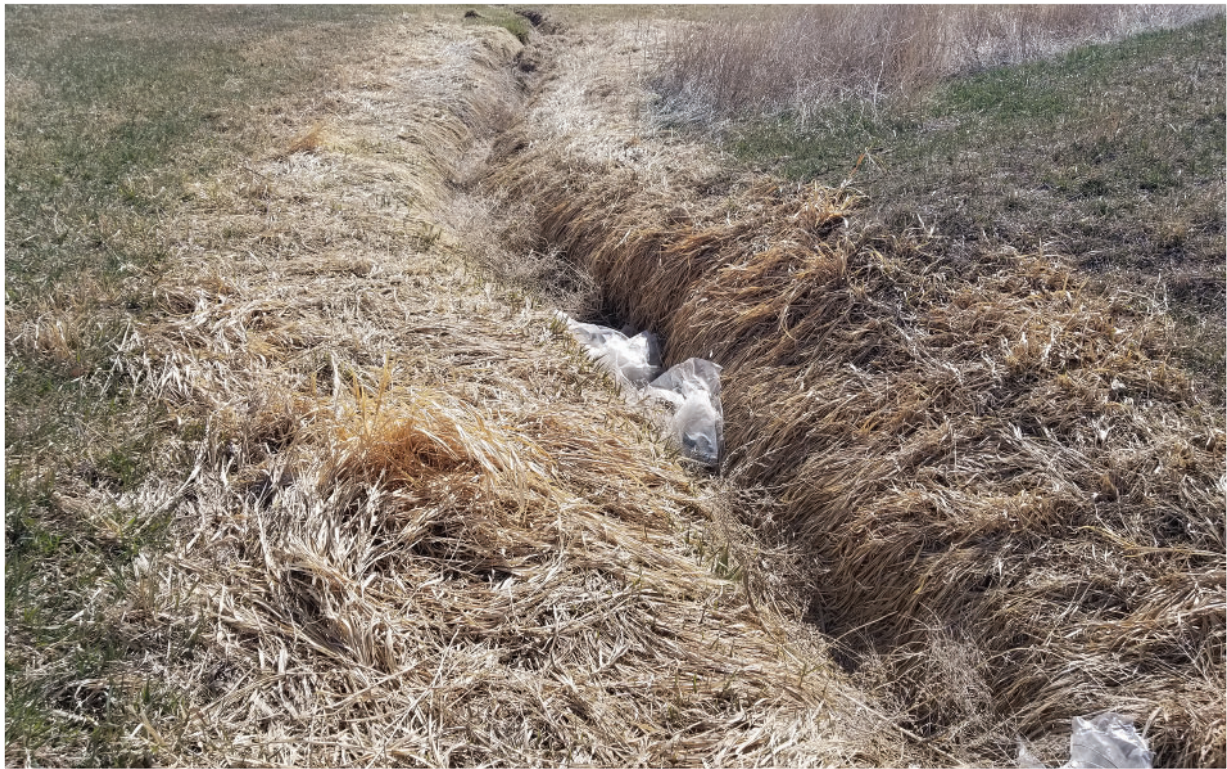
**Photo 8** - OHWM 8 in the central portion of the project area. View is to the east.

Portions of Drainage 2 appeared to have relatively permanent flow but may not have a continuous surface connection to downstream water. An isolated OHWM (OHWM 8) was also found along Drainage

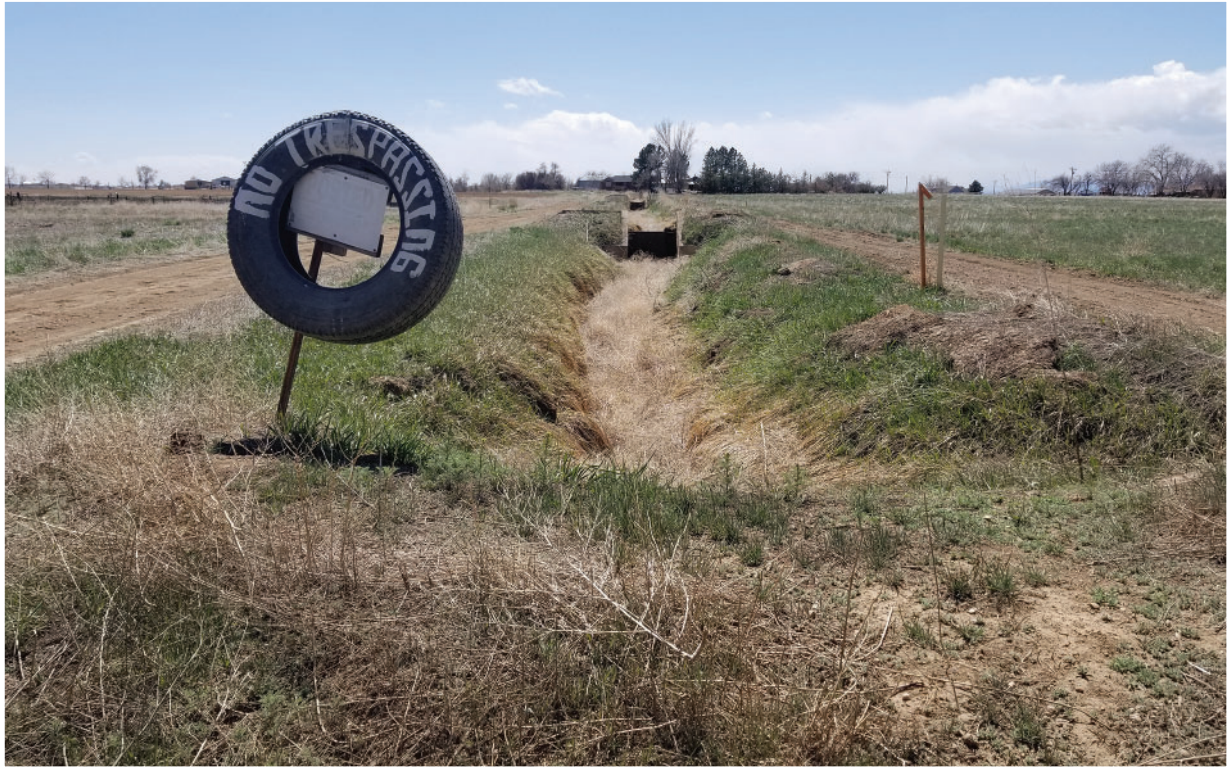
**Photo 9** - Community Ditch in the northwestern portion of the project area. View is to the southwest.

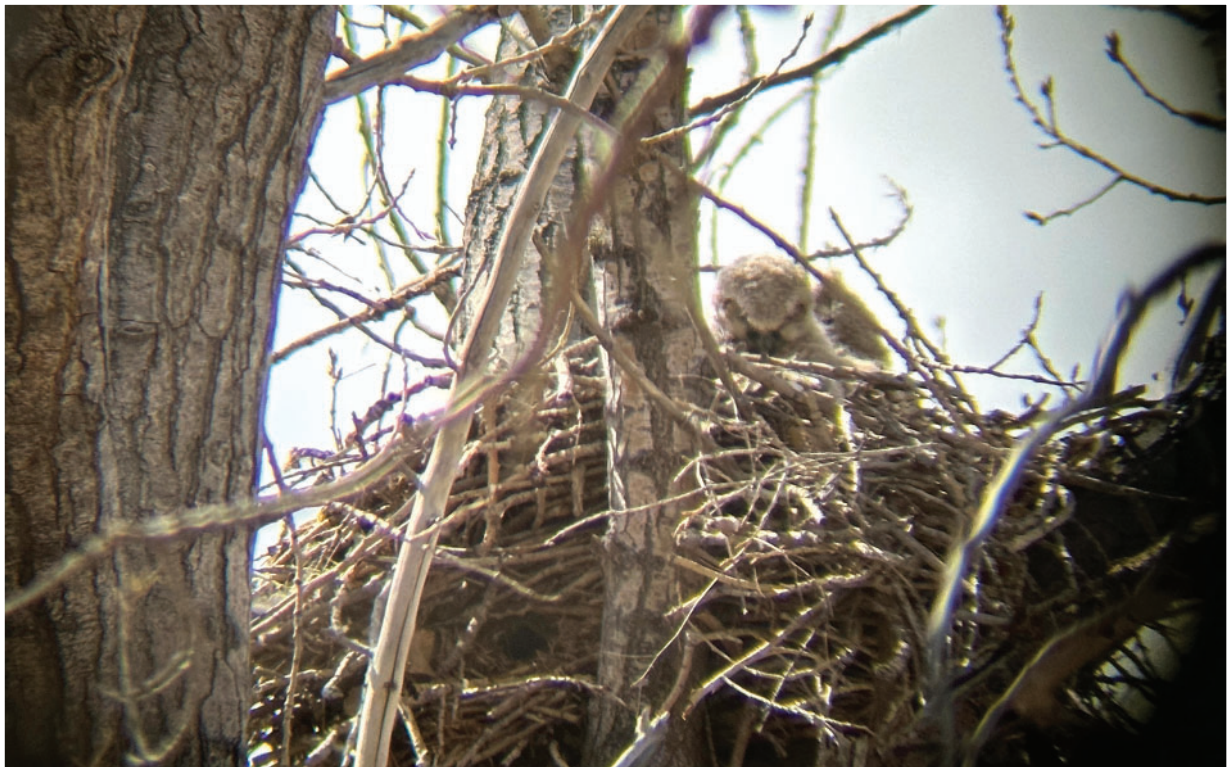
**Photo 10** - Active great-horned owl nest in the northeastern portion of the project area. View is to the southwest.

To avoid destruction of potential migratory bird nests, vegetation removal should be conducted outside of the April 1 through September 15 breeding season. CPW has identified the primary nesting season for migratory birds in Colorado as occurring from April 1 through September 15 (U.S. Fish and Wildlife Service 2009). However, a few species such as bald eagles, great horned owls, and red-tailed hawks can nest as early as December (eagles) or late February (owls and red-tailed hawks). Because of variability in the breeding seasons, ERO recommends that a nest survey be conducted within one week prior to construction to determine if the observed raptor nests or any other active nests are present in the project area so that they can be avoided. Additional nest surveys during the nesting season may also be warranted to identify active nesting species that may present additional development timing restrictions (e.g., eagles or red-tailed hawks).

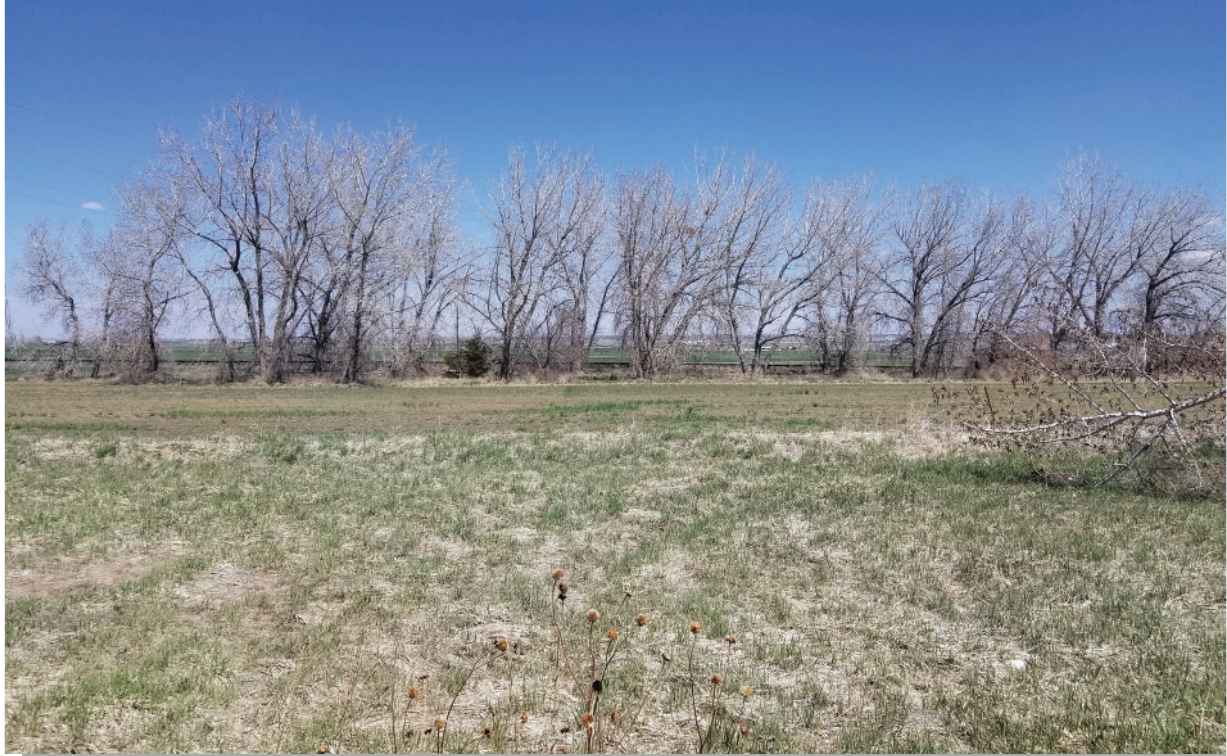
**Photo 11** - Likely active red-tailed hawk nest in the northern portion of the project area. View is to the northeast.

The CPW has recommended buffer zones of  $\frac{1}{2}$  mile for active red-tailed hawk nests and  $\frac{1}{4}$  mile for active Swainson's hawk nests. Activities that would directly impact an active nest, or that would encroach close enough to cause adult birds to abandon the nest during the breeding season, should be restricted. Construction activities that could potentially be within a red-tailed hawk or other raptor buffer zone should commence outside of the February 15 to September 15 breeding season. Consultation with CPW or the Service may be required if construction is proposed within a buffer zone of an active raptor nest. Although there is no CPW buffer designated for great horned owls, any active nest should be left undisturbed until the birds have left the nest. CPW recommends consultation with local CPW staff early in the planning phase of project proposals to assess and develop site-specific recommendations based on preexisting conditions (e.g., existing development, topography, vegetation, and line-of-sight to nest).
